Research Article

Understanding the Morphological Behaviour of River Chenab: A Case Study

Muhammad Abdul Rehman¹, Naveed Anjum¹, Muhammad Hamza Ali¹, Muhammad Danish Kaleem¹, Zaheer Ahmed¹, Junaid Ahmed Sidigy¹

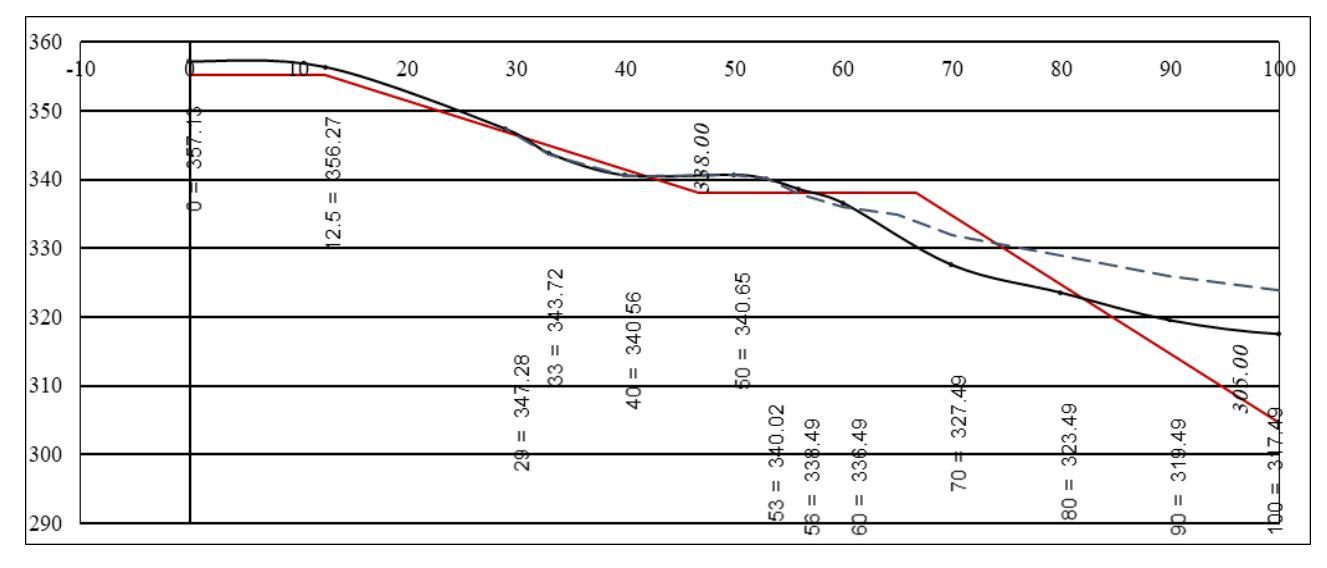
Figure 3. X-section at line 300

During the on-site survey at J-head Spurs RD: 36+700, J-Head spur RD: 40+900, Mole Head Spur RD: 42+200, and J-Head Spur RD: 48+800 RMB U/S of PJD Barrage, sounding observations were conducted to assess flood damages along these hydraulic structures. A sounding boat, equipped with a sounding rod and sounding rope, was utilized for field observations. Following the sounding observations and the plotting of cross-sections for all structures along various lines, it became evident that the entire stone aprons of these structures had suffered damage along all the cross-section lines. Varying degrees of damage, ranging from minor to moderate and heavy, were observed along different cross-section lines of these structures, as depicted in Figures 3 and 4. Specifically, the cross-section lines 300 and 400, U/S of J-head RD: 36+700 RMB, illustrate the damaged stone apron due to erosion.

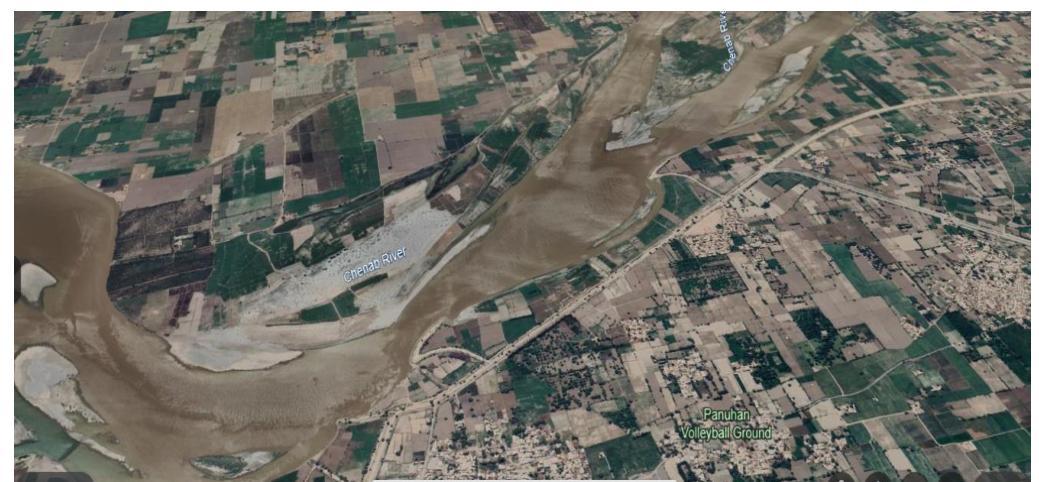
From RD: 52+000 to RD30+000 RMB U/S, the river flows towards the right along RMB in a single stream. To safeguard public infrastructures and the RMB from river erosion and damage, river training works including J-Head spurs, Mole head spurs, sloping spurs, stone studs, and apron along RMB are implemented in this stretch. This section consistently remains exposed to the risk of flood damage because the primary current of the river flows rightwards along RMB. Figures 5 and 6 depict the river's course from RD 30+000 to 52+000 along the RMB U/S of the barrage, highlighting the flow of the Chenab's main current. However, this specific stretch faces a potential threat of erosion along the RMB and the associated structures, such as spurs. These protective measures, installed with the explicit goal of safeguarding public infrastructure and the RMB, are susceptible due to the force and direction of the river's flow. The intricate nature of these observations emphasizes the complex and interconnected relationship between the river's flow patterns, the functionality of the barrage, and the ecological impact on the surrounding areas. A profound understanding and strategic approach to address these complexities are essential for devising effective mitigation strategies and ensuring the sustainability of infrastructure.

Figure 5. Vulnerable Reach RD30-52 RMB

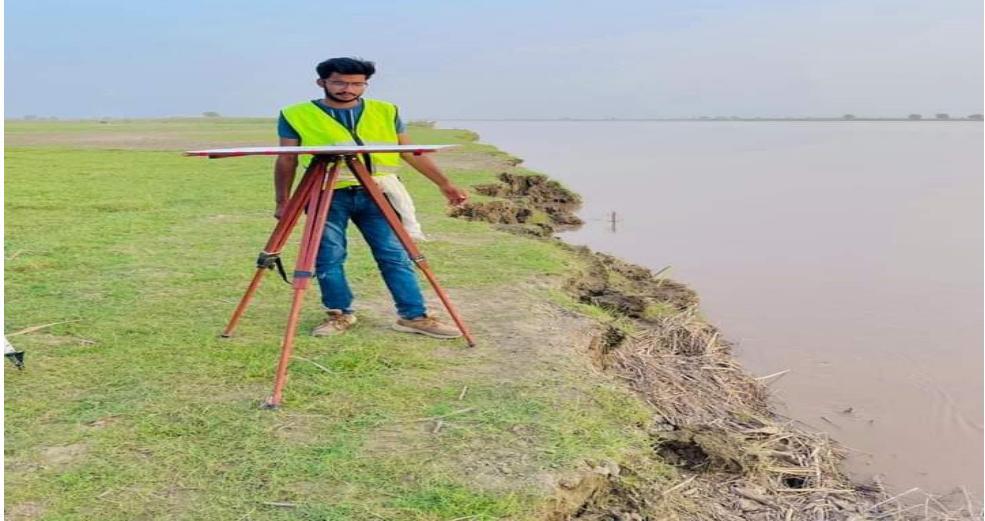
Figure 6. Vulnerable Reach RD40+000 RMB

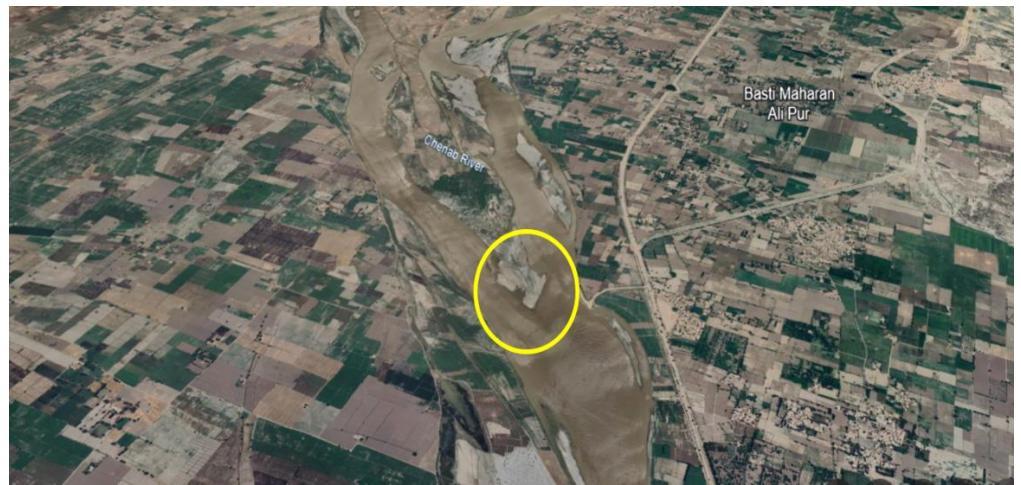
In Figure 7, it is depicted that the main flow of the Chenab River is separated into two sub-streams at RD 36+700 RMB U/S of the PJD Barrage. These two sub-streams individually approach the Barrage and merge at RD: 3+000 U/S of the PJD Barrage. Following the confluence of these sub-streams, a primary stream is formed, proceeding towards the main weir in front of Bay No.1-12. One of the sub-streams, on

the right side, flows along the RMB towards the Barrage, while the other flows on the left side, parallel to the LMB. The river Sutlej joins the Chenab River in this left side sub-stream approximately 15 km (measurement taken by Google Earth Software) U/S of the main weir. A permanent island has emerged between the aforementioned sub-streams from the starting point to the Barrage due to the limited water supply at the Barrage throughout the year. This island spans from Bay No.13-50, situated just 800 ft. (field measurement) away from the weir on the U/S side. The formation of this island diminishes the efficiency and flood-passing capacity of the Barrage.

Figure 7. Sub-streams formation at RD 36+700 RMB

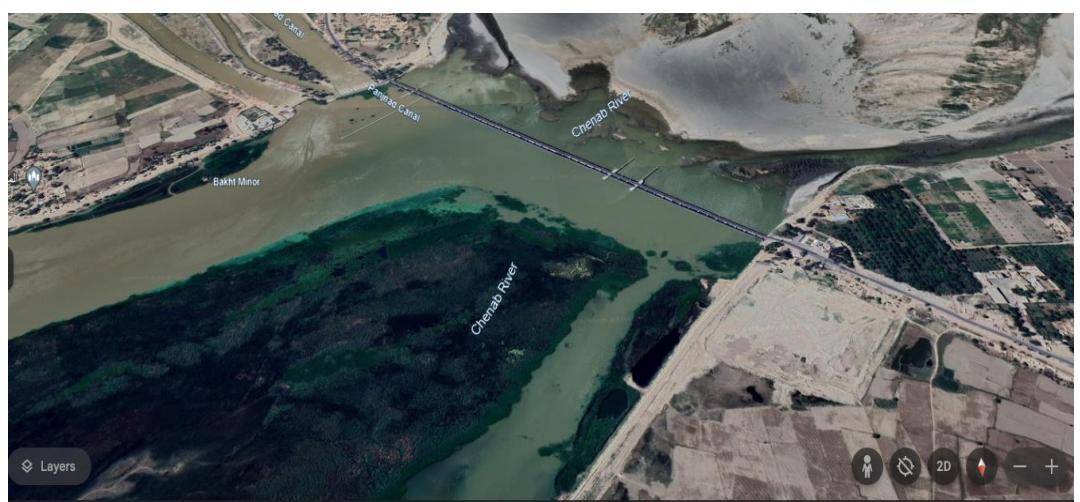
Figure 8. Aerial view of Panjnad barrage

In Figure 8, it is illustrated that the Chenab River approaches the barrage with two primary streams originating from RD30+000 U/S RMB and merging just 2000 ft. U/S (field measurement) of the main weir. This supply displays inconsistency throughout the year, mainly designated for canal off-takes. Consequently, to uphold the U/S pond level and cope with the variable supply, it becomes essential to keep the barrage gates closed. This underscores the challenges associated with the fluctuating river supply. The repercussions of this supply fluctuation are notably evident in the formation of islands or Bela in front of the main weir, particularly between gates no. 13-50, situated only 800 ft. (field measurement) U/S of the main weir. This Bela formation intensifies challenges during flood seasons, significantly reducing the barrage's capacity to pass floods and disrupting the smooth flow of the river's primary current towards the barrage. This critical scenario emphasizes the intricate impact of the river's varying supply on the operational efficiency of the barrage and its ability to effectively manage floodwaters.
