## CONDITION ASSESSMENT OF BUILDING CONCRETE STRUCTURES USING NDTs – CASE STUDY

**Abstract** – The quality of concrete and serviceability for three old buildings utilizing non-destructive testing (NDT) method of rebound hammer (RH) and ultrasonic pulse velocity (UPV) was assessed in the present study. Identification, classification and evaluation of in-situ concrete have helped us to decide whether these three buildings need to be repaired and in result extent their service life or it is not acceptable for its intended usage and they need to be demolished. To evaluate the level of deterioration in historical and fire-damaged buildings or infrastructures, non-destructive testing (NDT) methods can be used. In fact, NDT method employs inspection techniques to evaluate engineering properties to see if it is acceptable for its intended usage that does not need specimens to be crushed like the destructive testing method. The NDT method of rebound hammer (RH) and ultrasonic pulse velocity (UPV) in combination with conventional methods such as internal and external visual inspection and concrete color change to locate deterioration was used to evaluate the quality of concrete structures f

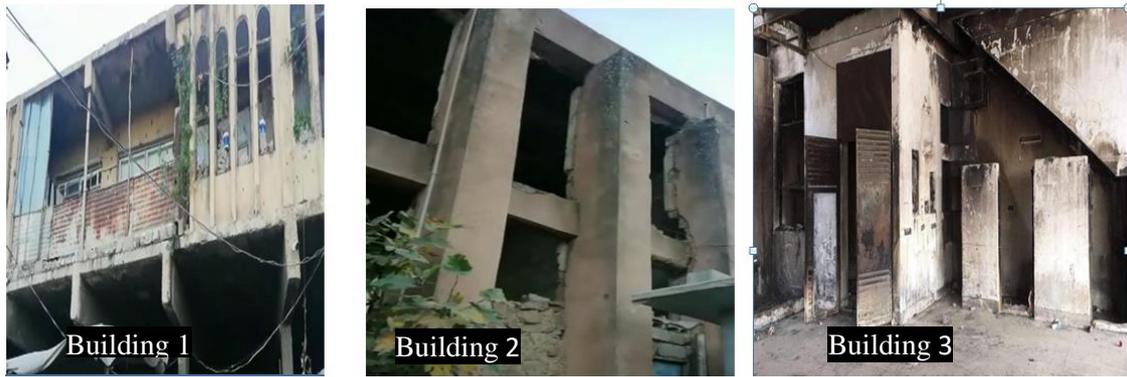
Figure 1: Three old and fire-damaged buildings

The three old buildings are located in a historical district of Shaqlawa, Erbil, Iraq. The buildings have been constructed between 1960 and 1970. The buildings were mixed reinforced concrete and masonry structures. One of those was a real fire-damaged building; however, according to the information received from the local officials, the fire duration was not too long. Testing included RH and UPV in combination with conventional methods such as internal and external visual inspection and concrete color change to locate deterioration and predict the compressive strength of concrete structures and for the assessment of the expected service life of the buildings (Figure 1). Due to the limits of each of the two tests for predicting concrete strength, both UPV and RH tests were employed to reduce the inaccuracies caused by the effect of the environment.

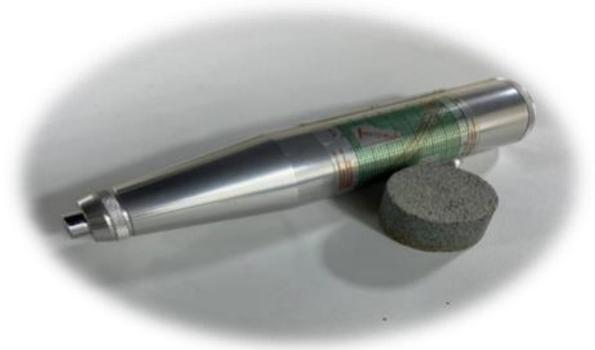
Figure 2: RH device used in the present study

Before RH testing, the rough surfaces of beams and columns at least 20mm far from the edge were selected and the surfaces were smooth, clean, and dry. Moreover, the loose parts were rubbed off. To obtain more accurate results by decreasing the measurement distance, 15 beam readings and 19 readings in the columns were collected. Classification of the quality of concrete based on RH is shown in Table 1. The RH device (Figure 2) calibrated against the test steel anvil with hardness of around 5000 MPa which was provided by the manufacturing company and again to ensure the accuracy of the measurement and operation at the end of the test the same procedure was repeated. The hammer (Figure 3) was held at right angles (90 degrees) to the concrete surface while collecting measurement values. The test was carried out horizontally on vertical surfaces, as well as vertically upward or downwards on horizontal surfaces [12-14]. All RH data are presented in Appendix.

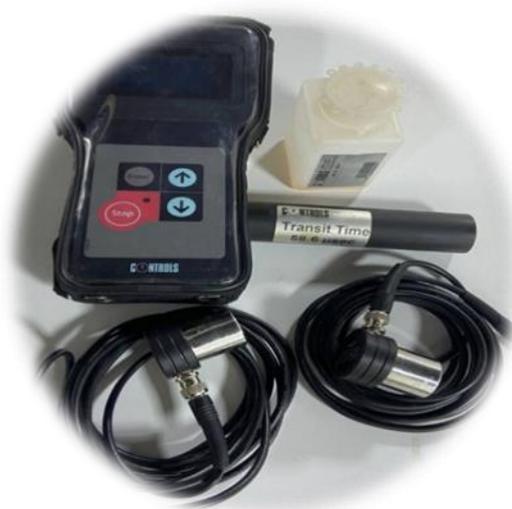
Figure 4: UPV device used in the present study

create a correlation curve between the two properties of UPV and strength. Before beginning UPV testing and to ensure the accuracy of the measurement and operation, the device (Figure 4) was calibrated and again at the end of the test the same procedure was repeated. It's done by using a standard calibration rod that comes with the device to measure the transit time. For this study, direct transmission was used and the velocity criterion for engineering quality of concrete grading is shown in Table 2. The UPV was measured by  $V = L / T$ . Where: V = pulse velocity, L = path length, and T = time taken by the pulse to traverse the path length. All UPV data are presented in appendix.

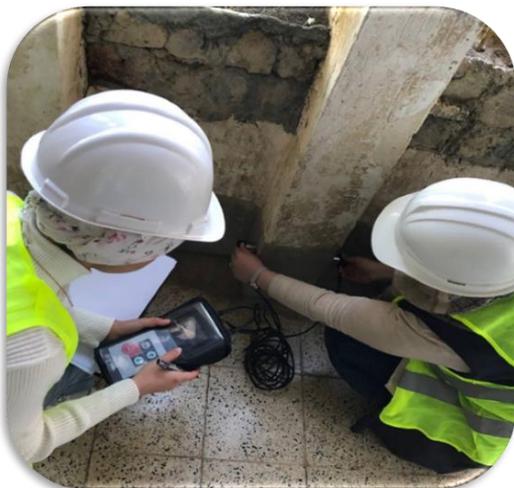
Figure 5: Collecting UPV values on beams and columns

Each concrete member was subjected to UPV testing in accordance with British standards [18]. The pulse velocities were measured between opposite surfaces in a direct technique. There were 15 beam readings and 19 readings in the columns with 3 or 4 readings at different selected surfaces of each column and beam. The transducers were placed precisely opposite each other on opposite sides of the concrete structure (Figure 5). The mean is used in this test as well as the strength derived from to

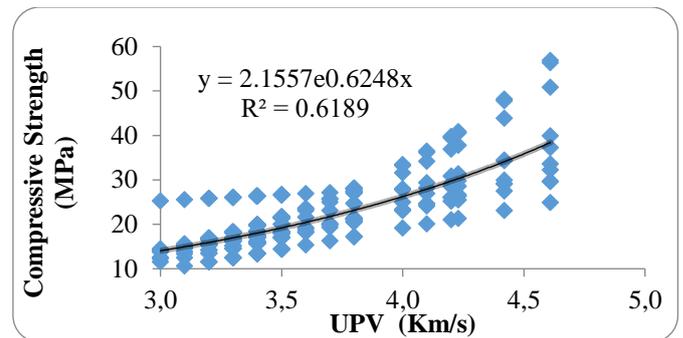
Figure 9: Correlation between the present and previous studies

of the building. According to the equations reported in the literature and the collected data of the present study, for any value of (UPV), there is a wide range of compressive strength. For instance, for the value of UPV equals to 4.1 km/s, the values of compressive strength are ranging from (20.07MPa) to (36.47 MPa). This can be used as a main indicator of the relationship between (UPV) and concrete compressive strength. Similar results have been reported elsewhere [25, 26]. We developed a new equation in the present study’s UPV values shown in Figure 9 that correlated out of the ten equations reported by other researchers.

For example, if the velocity is 4.1 km/s, the compressive strength in equation,  $C = 2.8 e^{0.53v}$  is equal to 24.60 MPa but in our equation  $y = 2.1557e^{0.6248x}$  is equal 27.93 MPa which is similar. Another study’s equation  $C = 2.016 e^{0.61v}$  for the same velocity is equal to 24.58 MPa but in our equation  $y = 2.1557e^{0.6248x}$  is equal to 27.93MPa; may be the difference is due to their recommendation that the surface of concrete should be wetted before testing. In another investigation, the following equation to calculate the approximate value of concrete compressive strength regardless of mix proportions has been proposed. In this equation  $Y = 0.3161 e^{(1.03 V^n)}$ , if the velocity is 4.1km/s, the strength is equal to 21.57 MPa. Furthermore, if we compare our results with the study reported in Table 7, in the equation  $f_c = 0.0011 e^{(2.315 V)}$  the result is equal to 14.57 MPa if the velocity is 4.1km/s [27-30]. According to the abovementioned details compressive strength seems to be increasing with increase in UPV and generally an exponential correlation exists between UPV and compressive strength.

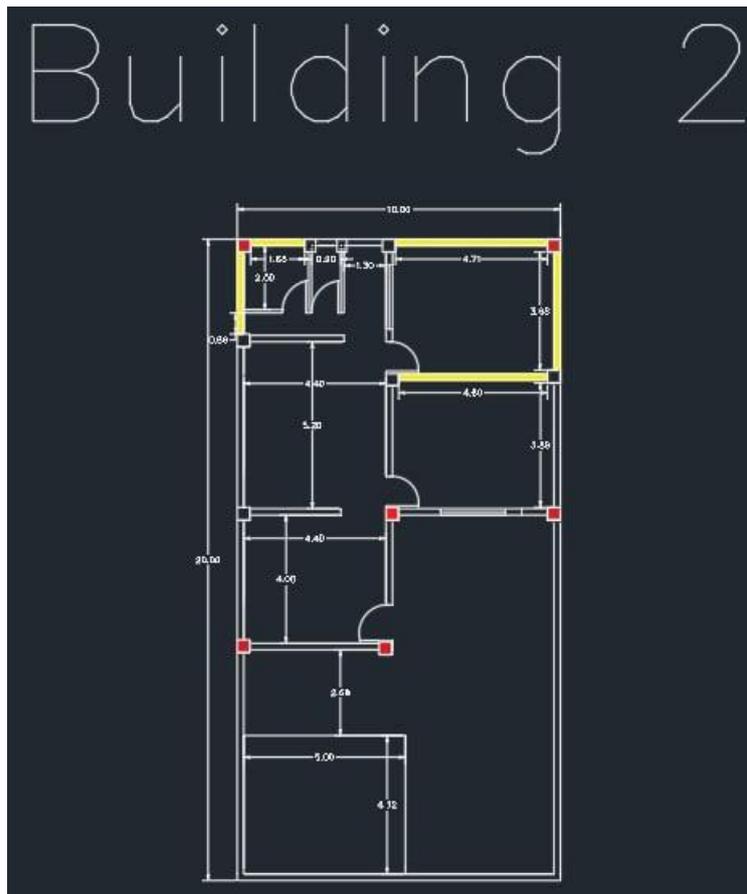
Figure 7: Selected beams and columns highlighted in red – Building 2

The results of the RH for building 2 for determining compressive strength and overall quality are assessed as “good/very good” layers. The results obtained in this old building showed that they have less visible cracks in the surface. We calculated the compressive strength from those data presented in Appendix. According to the results (Table 4) obtained on beams and columns (Figure 7) and structural damage assessment, we concluded that this building may be suitable to be repaired and to some extent the service life of the building.

After collecting the UPV data for building 2, the quality of the concrete can be classified as good concrete. The relationship between UPV and strength is affected by a number of factors including age, curing conditions, moisture condition, mix proportions, type of aggregate, and type of cement [24]. Table 7 shows the data and results for UPV for building 2 structures (Figure 7). According to the UPV data obtained and structural damage assessment, we concluded that building 2 is suitable to be repaired and in result to extent the service life

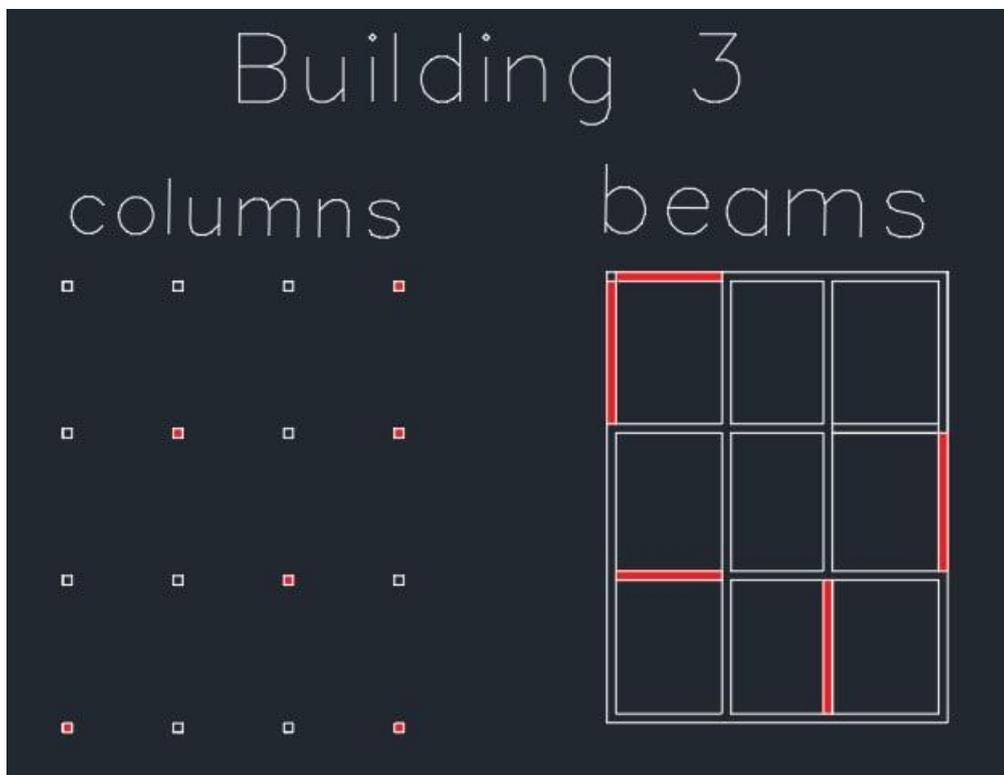
Figure 8: Selected beams and columns highlighted in red - Building 3

due to the short duration of fire and structures undamaged, the concrete is assessed as “good/very good” layer. We calculated the compressive strength from those data shown in Appendix. The RHs were not greatly reduced as fire couldn’t affect the concrete surface directly due to the short time of fire. RH purely gives estimation of strength on the external boundary of concrete structure and is unable to predict internal integrity of bond within concrete; therefore, RH alone is not an accurate predictor of compressive strength inside the structure. According to the data (Table 5) on building structures (Figure 8) and structural damage assessment, we concluded that building 3 is suitable to be repaired and in result to extent the service life of the building.

After collecting the UPV data (Table 8) on concrete structures (Figure 8) and analysing the results for building 3, the overall quality of the concrete structures can be classified as “good” concrete. The layer between paste and aggregate in concrete is called interfacial transition zone (ITZ) which generally defined as the weakest link in the concrete structure. In this case it didn't become fragile in this fire-damaged building due to the low fire time and low temperature exposure. In result strength and durability of concrete structures may be less affected. Similar to the results found for building 2, according to the UPV data obtained and the structural damage assessment in building 3, we suggest that building 3 is suitable to be repaired and in result to extent the service life of the building. According to the results obtained, data analysis, justification and discussion the NDTs can provide reliable assessments to local government officials and landlords of the buildings as decision makers. The decision that to what extent the building needs to be strengthened and which method of repair to be decided must be based on data analysis that shows if the levels of safety demanded by the national and international standard's recommendations are met. The strengthening and repair method will mainly depend on the structural scheme and materials used for the construction of the buildings.
