Working Range Optimization of Bearing Discs with 3 Axis Dynamic Testing

¹AYD Automotive Industry Inc, R&D Center, Konya-Selçuklu, Türkiye

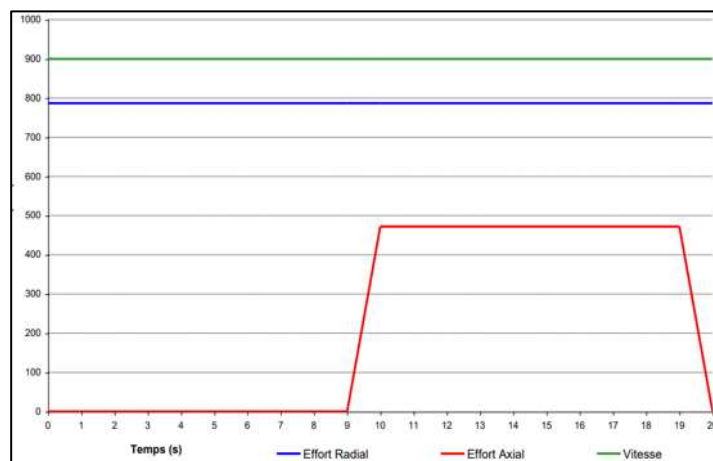
Figure 3.1 Test Instant Data Graph

The graph obtained during the test is given in Figure 3.1. All 6 parts have successfully completed 10,000 cycles.

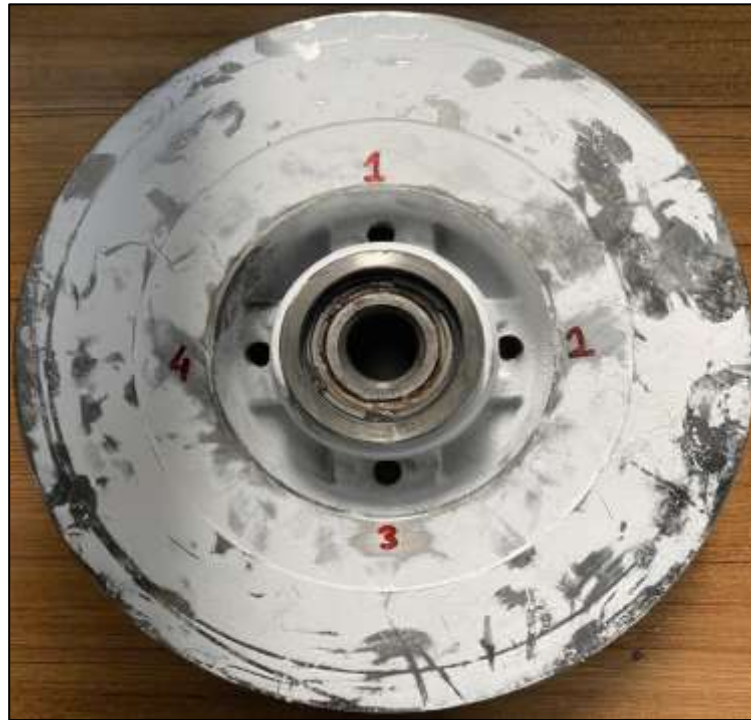
Figure 3.2 Post-Test General Image

At the end of the test, only a small amount of oil leakage occurred in the disc bearings. The general photo after the test is given in Figure 3.2, the front surface photos after the test are given in Figure 3.3, and the back-surface photos after the test are given in Figure 3.5.

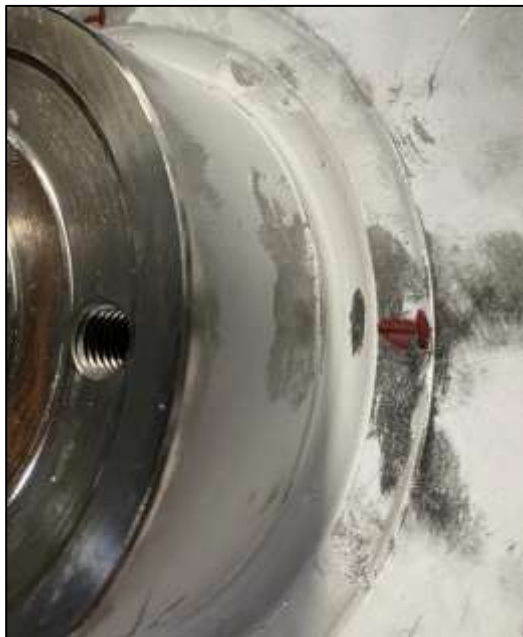
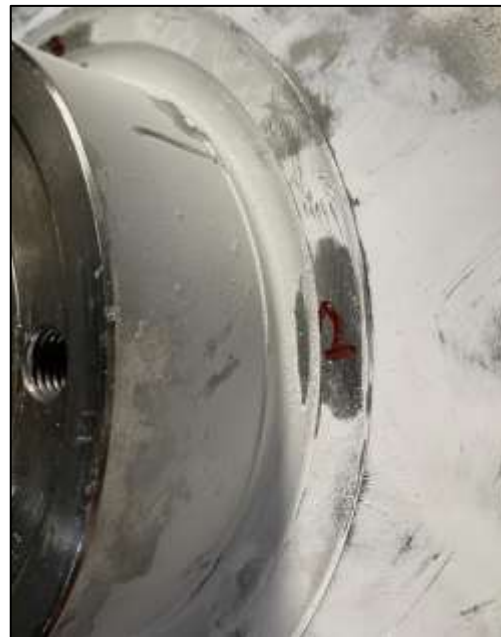
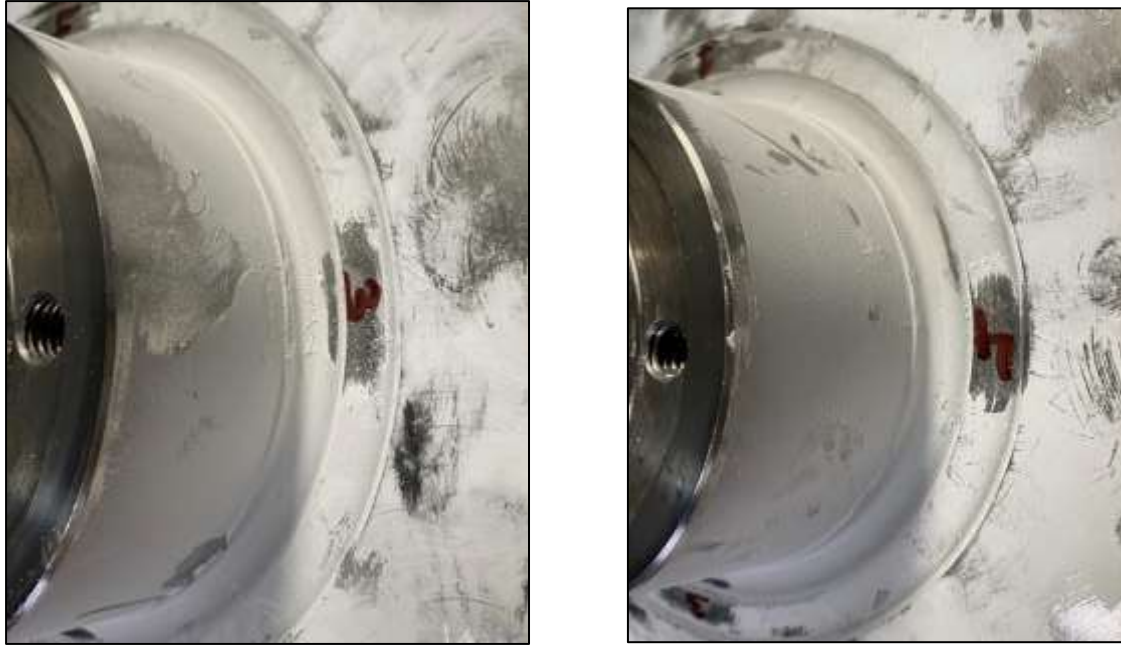
Figure 3.3 Front Surface Photos After Testing

During and after the test, the disc was sprayed to identify any small cracks or breaks. Apart from this, the test system is set to stop itself if the smallest limit is exceeded. No cracks or defects were found on the front surface.

In the dynamic tests, all 6 samples successfully completed their tests and no defects were found on their front surfaces, as seen in Figure 3.3.

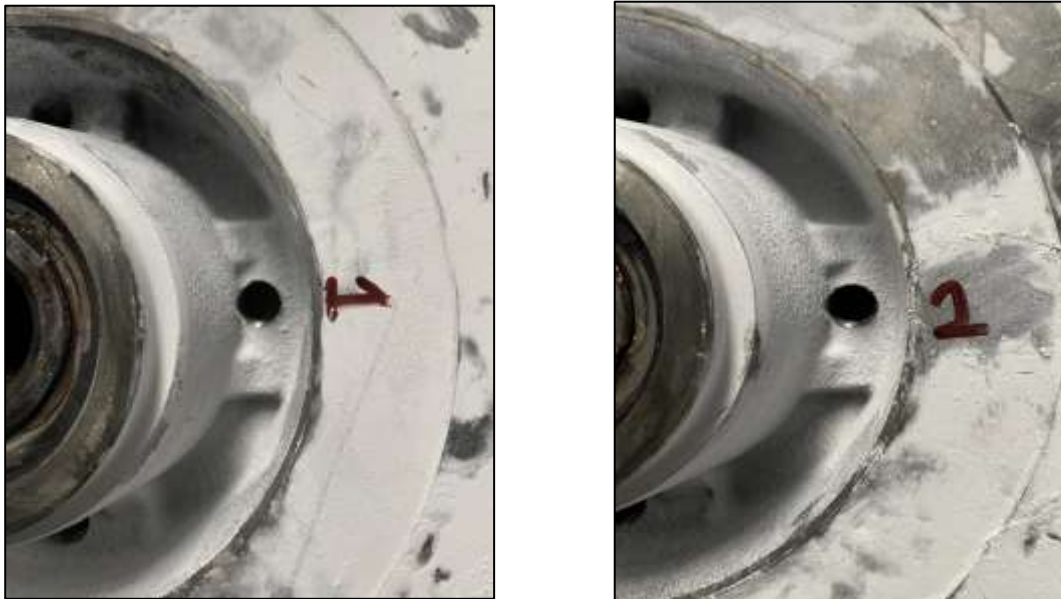
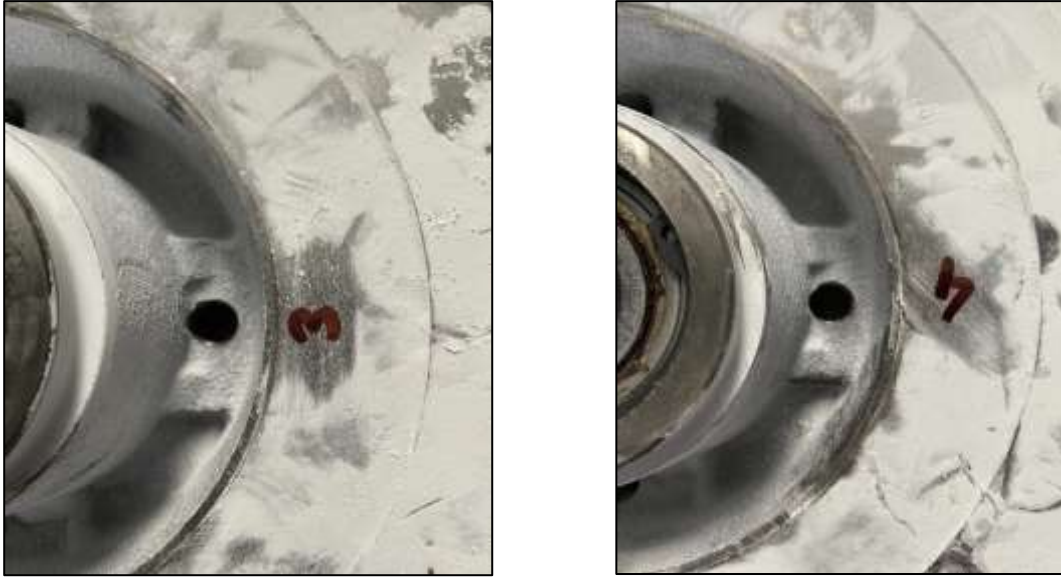
Figure 3.4 Back Surface Photos After Testing

In dynamic tests, all 6 samples completed the tests successfully and no defects were found on their back surfaces, as seen in Figure 3.4.
