From Failure to Insight: The Silver Bridge Collapse in Engineering Perspective

Sufwan Ahmed *¹, Izza Lodhi¹, Leena Asghar¹, Hajra Altaf¹, Layba Hafeez¹, Abraham Jabbar¹,
Erum Aamir¹

¹IESE/ NUST (National University of Science & Technology), Pakistan

(2nd International Conference on Pioneer and Innovative Studies ICPIIS 2025, January 30-31, 2025)

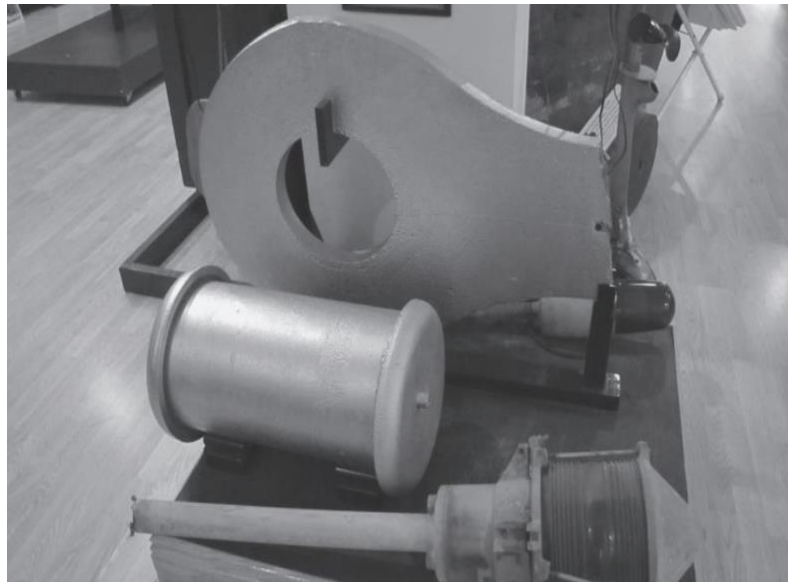
The most significant feature of the Silver Bridge was its eye-bar suspension system, which was the only type of suspension to differ from the traditional wire rope suspension bridges. Each eye-bar was a steel bar that was long in length with cylindrical holes at the ends. The bars were linked in pairs using big, 11-inch in diameter steel pins. Such bars transferred tensile forces from the main suspension cables to the vertical suspension members known as suspenders. It also helped distribute the load more uniformly throughout the structure of the bridge and avoided suspension cables, which are much bigger in size and less conventionally used. Each eye-bar was under high tensile stress, with the traffic and wind forces loadings being distributed across the system. However, the design was inherently vulnerable to failure if one of the components failed due to SCC or fatigue. The phenomenon of SCC results when the steel is subject to tensile stress under a corrosive environment condition, which was compounded with the humid atmosphere around the Ohio River. Failure due to corrosion or fatigue from a single eye-bar sparked a cascade that brought the bridge down. This, in turn, highlighted the necessity of a more robust design with redundancy to prevent such a catastrophic failure from propagating throughout the structure.

Fig. 2 Eye-bar [11]

It was with a tremendous cracking sound that the event began, which the witnesses saw, followed by an almost instantaneous failure of the bridge. The first stage of failure started with the development of a small crack, 0.1 inch deep in one of the eye-bars. The source of this crack was fretting wear—a form of mechanical wear at the contact points of the eye-bar joints—and propagated under the steady load of traffic and environmental stresses. When the crack grew, it caused a failure of the eye-bar. Then, it transferred the load to adjacent components. The redistribution of load happened suddenly. This placed a lot of stress on the remaining eyebars, which had been already weakened by stress corrosion and fatigue for many years. Within seconds, the structure of the bridge was broken, and the whole span collapsed. This series of failures at such a rapid pace highlights the design without redundancy because one component's failure could not be absorbed by the remaining structure.

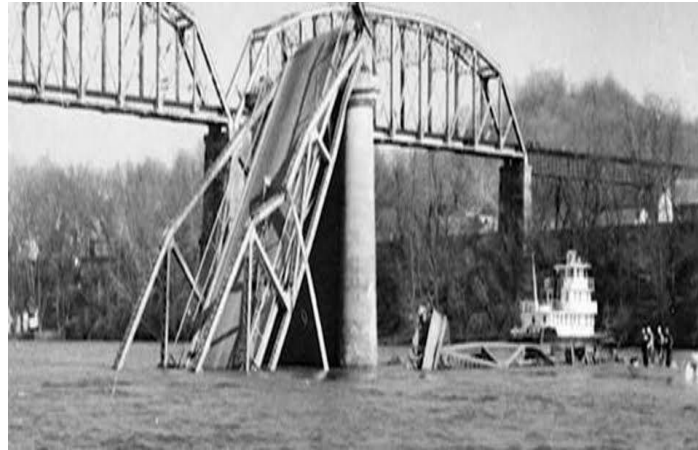
Witness testimonies played a crucial role in reconstructing the events surrounding the Silver Bridge collapse. The following statements provide crucial insights into the moment of failure and the immediate aftermath. John Smith, who survived the disaster, was crossing the bridge when the disaster happened. He remembered hearing a "loud popping sound" just before the bridge gave way. He described the eye-bars moving and the rapid fall of the entire bridge into the Ohio River. This report shows how fast the failure was and how the bridge could not support the load once the crack was created. Fire Chief David Richards, among the first to arrive on the scene, described the bedlam that ensued after the collapse. He said he heard "metal snapping" before everything went silent, and he noted how difficult it was to rescue survivors, given the frigid waters of the Ohio River. His testimony shed light on the challenges faced by emergency teams in the wake of the disaster. Sarah Turner, an eyewitness from a building nearby, could see the collapse from afar. She described the bridge "shaking before it fell," with cars tumbling into the river. Turner added further context to the series of events that led to the failure, describing signs of distress in the structure of the bridge before the complete collapse.

Fig. 4 Silver Bridge Collapse 1967 [17]

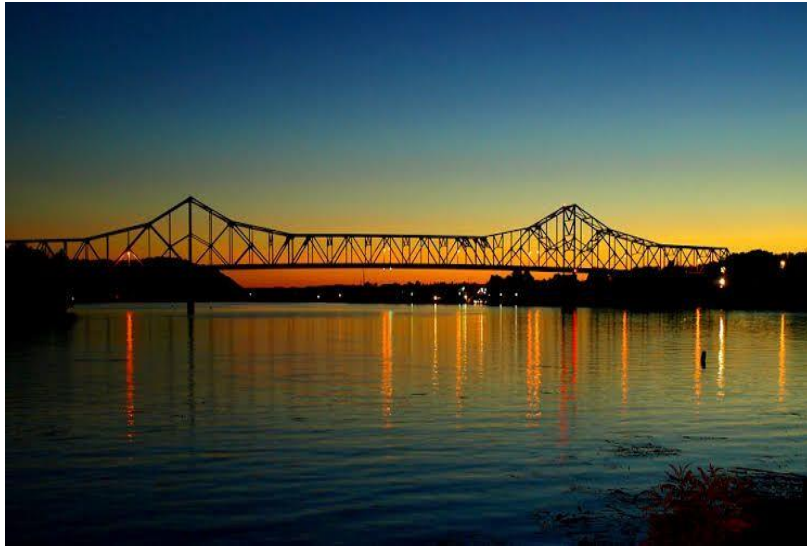
In response to the collapse of the Silver Bridge, the Silver Memorial Bridge was constructed to replace the original bridge. The Silver Memorial Bridge was built about one mile downstream from the site. It was completed and opened to the public in 1969. The modern suspension techniques and advanced materials used in the new structure were designed to avoid the failures of the predecessor. One of the improvements was that redundancy was incorporated into the design, such that failure of one part would not cause a catastrophic collapse. In addition, during the construction process, rigorous inspection protocols were conducted to identify potential issues before they could compromise the structure.

Engineering improvements that occurred with the Silver Memorial Bridge, like changes in materials, for example, in high-strength steel, corrosion-resistant coatings, and in design features, for instance, redundant load-bearing systems and better suspension methods. These innovations corrected the flaws in the original bridge. The challenges faced during the construction of the Silver Memorial Bridge were geographical or environmental factors, the need for quicker completion to restore traffic flow, or the complexity of working around the site of the previous disaster. The new bridge reconnects West Virginia and Ohio; the importance of this to the regional economy; how it impacts local development. Also, consider the aspect of how the bridge made transport better for industries, business people, and general citizens going about their daily work. The environmental impact assessments or considerations taken when planning and constructing the Silver Memorial Bridge includes efforts to minimize the environmental impact on the surrounding area and make the bridge more green than its predecessor. Over the years, the Silver Memorial Bridge has been maintained and upgraded since its construction with major refurbishments, retrofits, or technological improvements being made to keep the bridge functional and safe. The bridge memorializes the deaths that occurred as a result of the 1967 collapse by using examples of commemorative plaques, events, or public education.

Fig. 5 Silver Memorial Bridge [16]
